MODELLING OF HAZARDOUS OPERATING MODES OF RUBBER-CORD COUPLING IN FEM ENVIRONMENT

Dmitrijs Gorbacovs, Pavels Gavrilovs, Janis Eiduks

Riga Technical University, Latvia

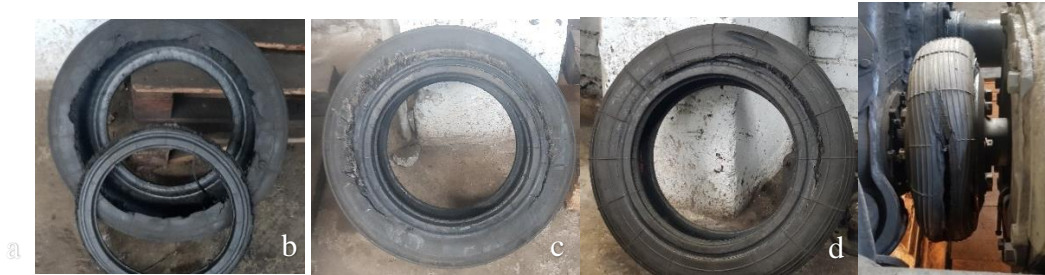
Upon visual inspection of all failed 58 rubber cord couplings, it was found that the reason for the failure of 57 of them was the rupture of the side surface, and the failure of one coupling was the destruction of the upper surface. The general view of coupling failures is shown in Figure 2.

Fig. 2. **Types of failures of rubber-cord couplings:** a; b; c – rupture of the side surface; d – rupture of the upper surface

3. According to the modelling results, it is found that at axial, radial and angular deflection loaded areas coincide with the failure areas of in-service couplings.

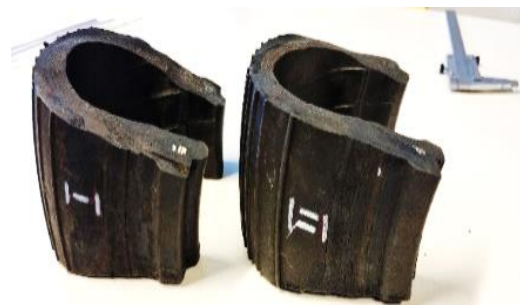
To determine the mechanical properties of the material, cyclic and single-tensile tests were performed on 6 fragments of rubber-cord couplings. The general view of fragments 1 and 2 is presented in Figure 5.

Fig. 5. General view of fragments of rubber-cord couplings

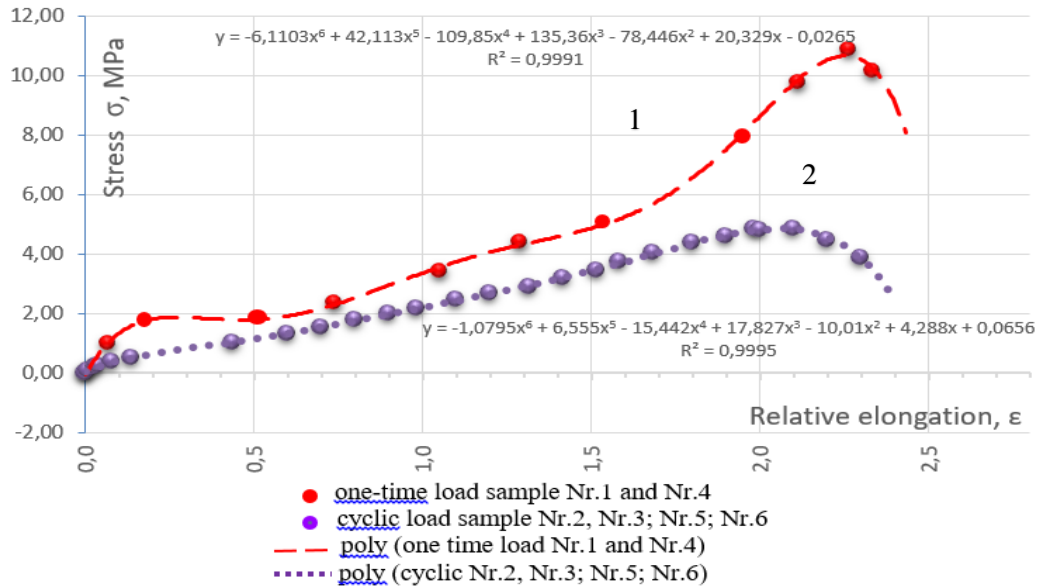
The 6th order polynomial was chosen based on the results of the smallest value of the standard deviation R2 (Fig. 6).

Fig. 6. Comparison of unilateral tensile test results

In order to create a numerical model of the coupling material, a comparative analysis of the results of several tests was carried out for stress dependence on the relative deformation $\sigma = f(\epsilon)$ [9]. In order to confirm the accuracy of the results, the test results were approximated with a polynomial function and the resulting (summarised) test graph for the dependence of stress on relative deformation was constructed [10-11].

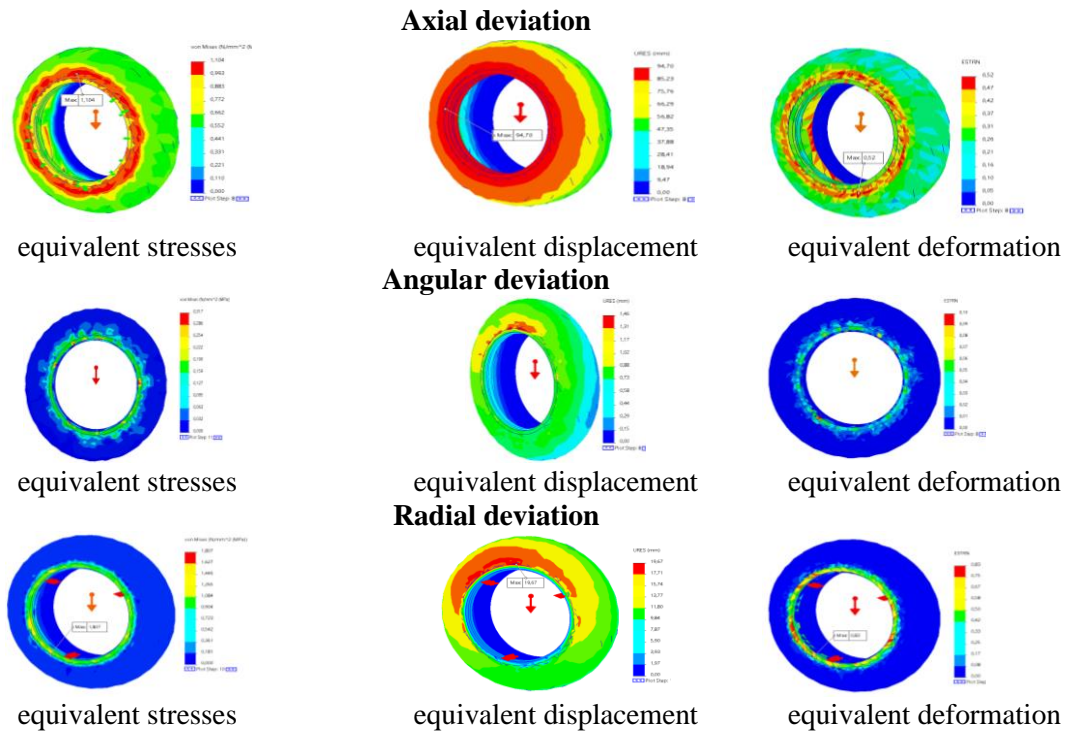
Modelling the influence of axial radial and angular deflection on the coupling is show in Figure 8.

Fig. 8. Modelling of maximum deviations and torque at 130 rpm

1. When modelling the maximum axial, radial and angular deviation data, it was found that the action of total stresses from axial, radial and angular deflections under cyclic loading is dangerous to the couplings and can cause damage of the side surface, because it is 3.21 MPa, which is more than 60% of the strength limit σ_b (4.87 MPa), which under cyclic loading causes the lateral surface to collapse.

4. It is proposed as an immediate action to limit the operation of rubber cord couplings above the train speed of 110 km·h⁻¹ (1670 rpm). As a long-term solution for new couplings, the recommendation is to modify the geometric parameters of the rubber cord shell. Also, it is necessary to prevent continuous operation of the coupling at low rotation speed in the range up to 130 rpm.
