CONSTRUCTION FEATURES OF POTATO HARVESTERS AND THEIR INFLUENCE ON DAMAGE TO POTATO TUBERS DURING HARVESTING

Vasyl Achkevych, Borys Onyshchenko, Iurii Gumeniuk, Oksana Achkevych
National University of Life and Environmental Sciences of Ukraine, Ukraine
achkevych@nubip.edu.ua, borysoniscenko@gmail.com, gumenyuk.yurii75@gmail.com,
achkevych@gmail.com

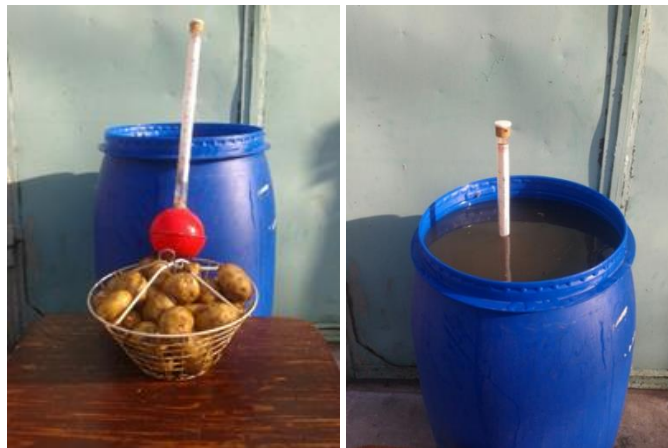
Fig. 3. Device for measuring dry matter

2. Determination the percentage of dry matter of potatoes. Potatoes consist of 70-75% water and 20-30% dry matter. The dry matter content is important for the percentage of damage. The higher the percentage, from 25 to 28%, the greater the probability of damage when the potatoes pass through the potato harvester. The content of dry matter in potatoes was determined using the device in Fig. 3. To do this, you need to collect 3 kg of potato tubers and place them in a container with water. The

scale of the device will show the percentage of dry matter. According to the received data, it is necessary to adjust the operating mode of the potato harvester.

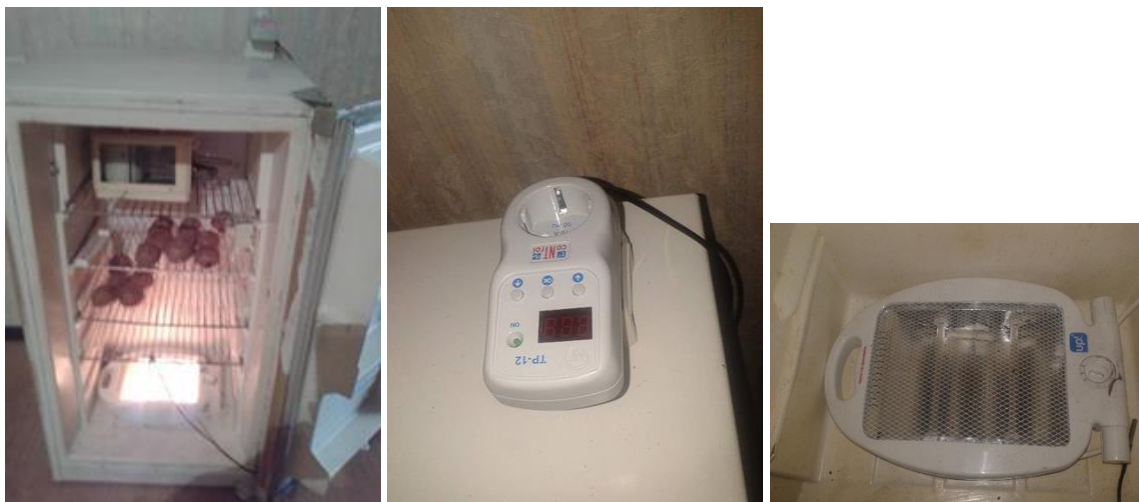
Fig. 4. Thermal cabinet, thermal relay and heater

3. The selected samples are placed in a thermal cabinet. The conditions and time of exposure of experimental samples accelerate the processes occurring in potatoes during long-term storage in potato warehouses.

The warming cabinet is designed to accelerate this reaction by creating warm and moist conditions that promote faster bruising. Optimal development of bruises is at a temperature of 30 °C and a relative humidity of 97% within 12 hours. When the hot box bruising testing is used in conjunction with an electronic potato chute, the shocks measured by the electronic potato during harvest or sorting can be effectively calibrated by relating them to the level of bruising that occurs in the hot box. This allows to take measures earlier, which leads to a decrease in the number of bruises and damage to potatoes.

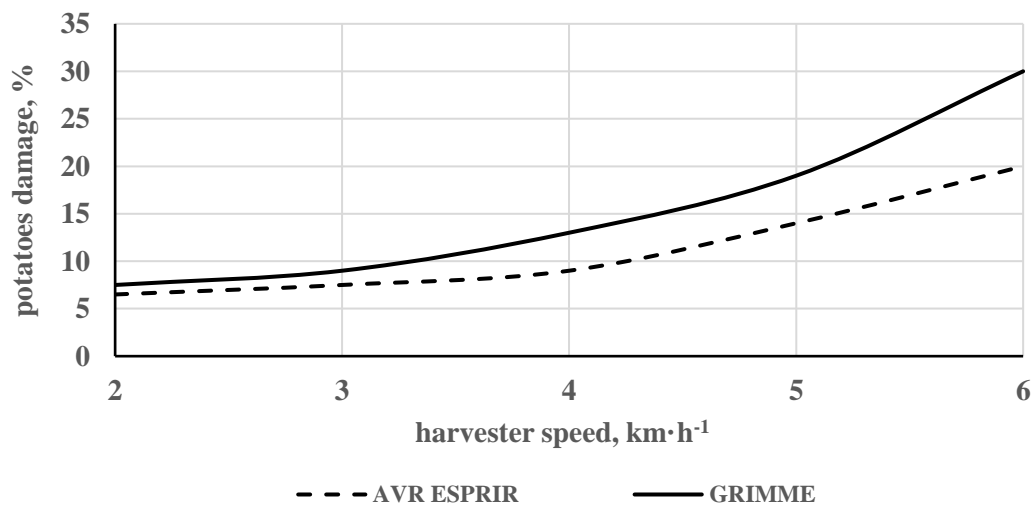
Fig. 11. Dependence of potato damage on the speed of the potato harvester

Based on the conducted research, a graph of the dependence in Fig. 11 shows the damage to potato tubers from a change in the speed of the potato harvester. Both combines had the lowest injury percentage at a minimum speed of 2 km·h⁻¹. This is explained by the low speed of movement of potatoes along the conveyors of the combine.

When the speed of movement increases to 4 km h^{-1} , the percentage of damage also increases, but not significantly. In the GRIMME potato harvester, the percentage of damage increased from 7 to 13%, in the AVR ESPRIT combine from 5 to 9%. With a further increase in the movement speed of the unit, there is a significant increase in the injury rate of potato tubers in both harvesters. At a maximum speed of 6 km h^{-1} , the percentage of damage reaches 20 and 30%, respectively. This is explained by the large supply of potato piles to the conveyors of the combine. The entire pile does not have time to sift through and damage occurs with lumps and residues. A large percentage of damage in the GRIMME harvester is due to many potatoes that simply cannot pass from the unloading conveyor to the inspection table (bottle principle).

3. Both harvesters had the lowest injury percentage at a minimum speed of 2 to $4 \text{ km} \cdot \text{h}^{-1}$. This is explained by the low speed of movement of potatoes along the conveyors of the combine. At the maximum speed of $6 \text{ km} \cdot \text{h}^{-1}$, the percentage of damage reaches up to 20% - AVR ESPRIT and 30% - GRIMME, respectively. This is explained by the large supply of potato piles to the conveyors of the combine.

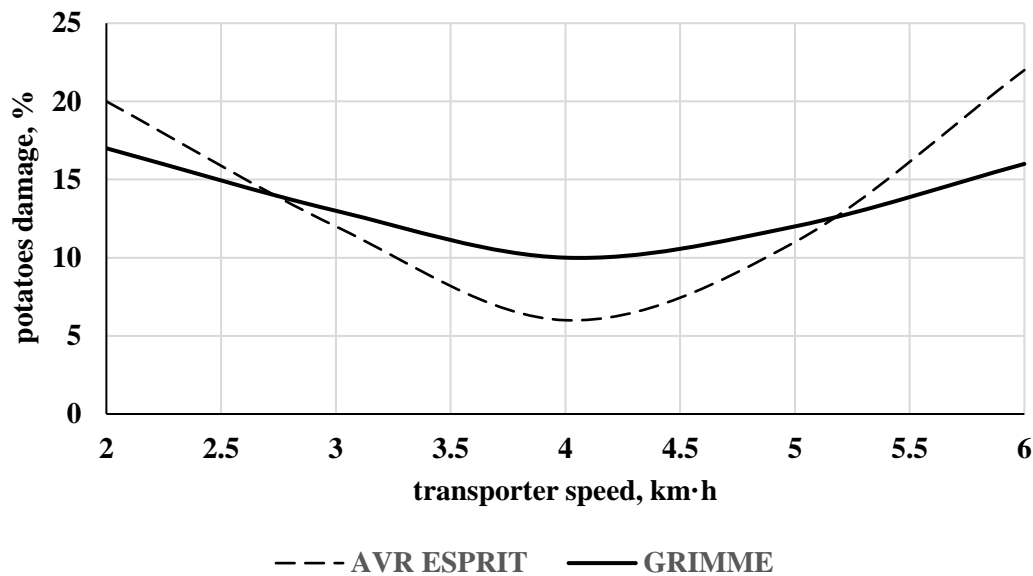
Fig. 12. Dependence of potato damage on the speed of conveyors at the combine speed of $4 \text{ km} \cdot \text{h}^{-1}$

Also, the problem of damage to potato tubers is the discrepancy between the speed of the conveyors and the speed of the potato harvesting unit. Fig. 12 presents a graph of the dependence of damage to potato tubers on the change in the conveyor speed at the combine speed of 4 km h^{-1} .

Analysis of Fig. 12 indicates that the minimum damage to potato tubers will be at the same speed of movement of the harvester and conveyors. At a significantly lower speed of the conveyors, in relation to the speed of the harvester, the percentage of injuries in both cases is quite significant. In the AVR ESPRIT combine, it decreases from 20% at a speed of 2 km h^{-1} to 7% at a speed of 4 km h^{-1} . In the GRIMME harvester, the percentage of damage is reduced from 17% to 10%. This is explained by the large amount of potato piles on the first conveyors. Also, when the speed of the conveyors increases, the percentage of damage increases significantly. This is the result of the lack of potatoes on the

conveyors. Potatoes pass through the conveyors very quickly and bounce off. In some cases, they even roll back.

4. Minimal damage to potato tubers will occur at the same speed of movement of the harvester and conveyors. At a significantly lower speed of the conveyors, in relation to the speed of the harvester, the percentage of injuries in both cases is quite significant. In the AVR ESPRIT combine, it decreases from 20% at a speed of $2 \text{ km} \cdot \text{h}^{-1}$ to 7% at a speed of $4 \text{ km} \cdot \text{h}^{-1}$. In the GRIMME harvester, the percentage of damage is reduced from 17% to 10%. This is explained by the large amount of potato piles on the first conveyors.
