EVALUATION OF SHEET DEGRADATION WITH SURFACE TREATMENT

Sylvia Kusmierczak, Natasa Naprstkova, Jaroslava Svobodova
Jane Evangelista Purkyně University in Ústí nad Labem, Czech Republic
kusmierczak@fvtn.ujep.cz

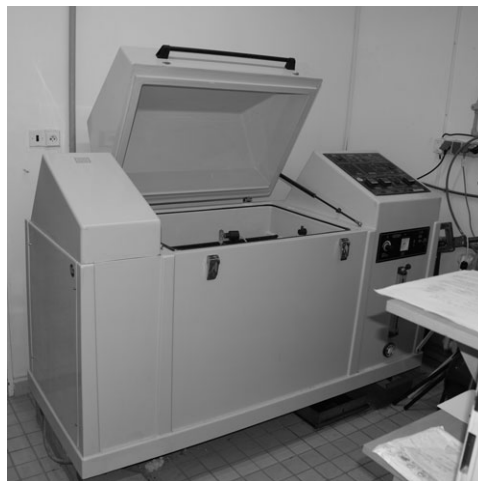
Fig. 1. Corrosion chamber

The samples were on the surface received by a full phosphating, alkaline degreasing and passivation [2]. The samples were exposed to corrosive load according to EN ISO 9227 at 240, 480 and 720 hours. For the experiment a diagnostic corrosion device Liebisch ® was used (Fig. 1).

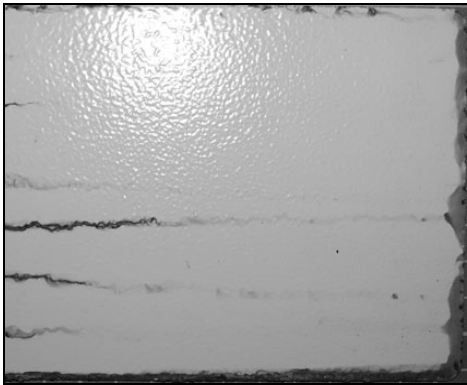
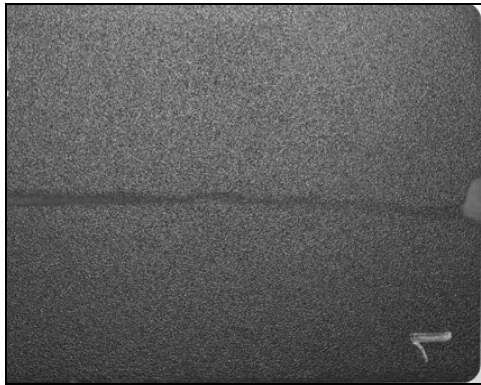
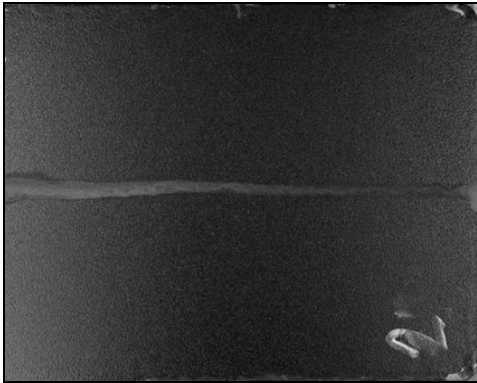
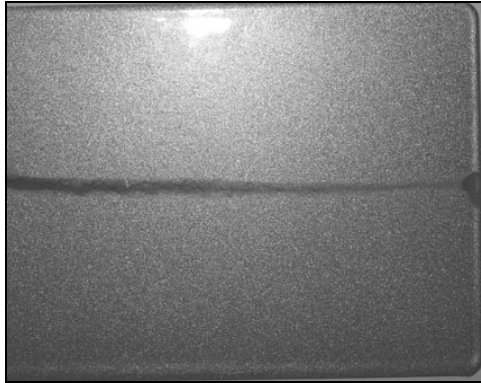
Samples after corrosion load

S/1	S/2

S/3	S/4

Macroscopic evaluation describes the behavior of the samples after exposure to corrosive load. Table 1 presents the sample after corrosion load.

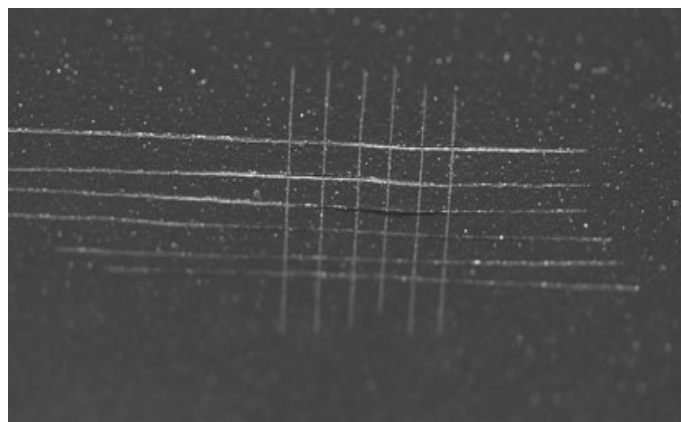
Fig. 2. S/3, Cross-cut test

The evaluation was performed according to ČSN EN ISO 4628-2 Assessment of the degree of blistering, ISO 4628-3 Assessment of the degree of rusting, EN ISO 2409 Paints - Cross-cut test. As an example there are reported the scores of the sample S/3 (Fig. 2).

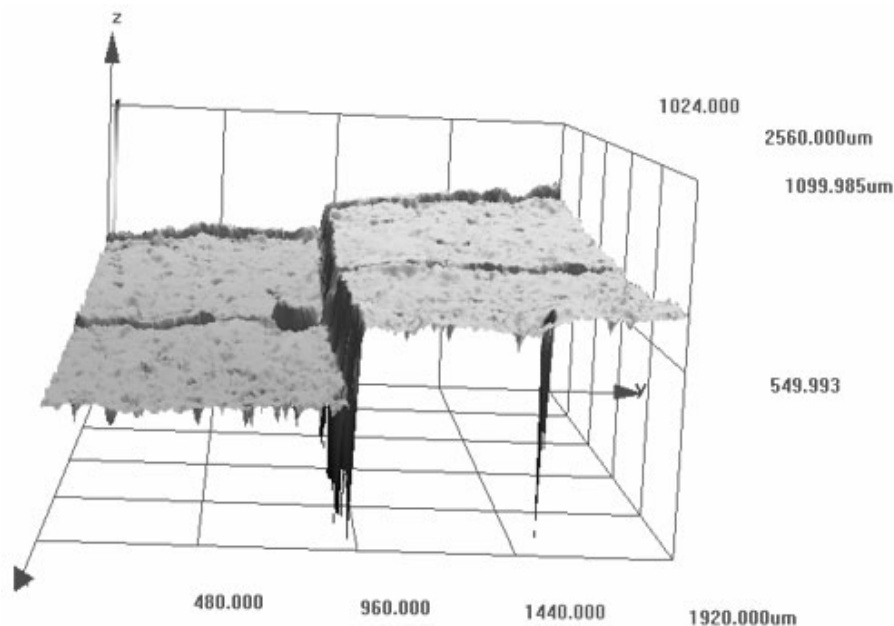
Fig. 3. S/3, sample corrosion, delamination

This sample shows after a cross-cut test also damaged paint finish. There was peeling off paint. The paint did not snap to the base material and produced a coherent surface coating with no ties to the basic material. In Figure 3 there is a visible ripple of the surface coating and paint damage on the cross-cut test. The sample S/3 was classified as grade 5. Corrosion under the paint in the place of the cross-cut test did not come out. For this sample a confocal microscope was used and a 3D model was made, which highlighted a paint not connecting with the basic materials, Figure 3. The results of the macroscopic analysis for all samples are listed in Table 2.

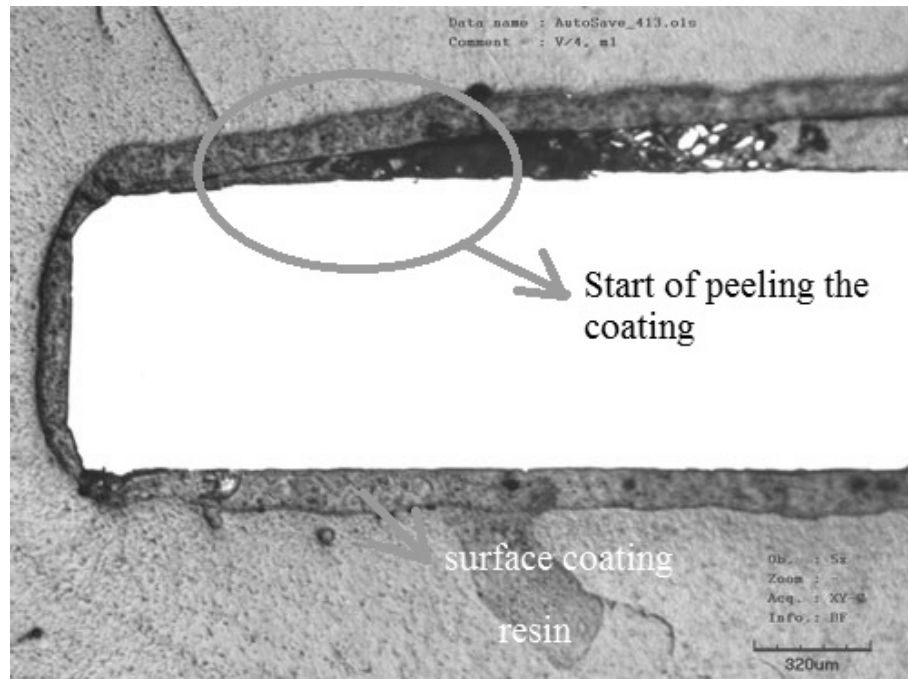
Fig. 4. V/4, state of the corrosion protective layer load

The sample S/3 is documented in Figure 4 and 5.

In this sample the edge coating was not stripped away. Peeling is evident only at a distance of approximately 40 μm from the edge of the sample. This peeling off could be caused by imperfect surface preparation. The bottom layer of the coating is uniform and is adjacent to the base material. The top layer of the coating is rugged. The pore is located on the coating with the size of about 60 μm . Distribution of pores in the coating is irregular.

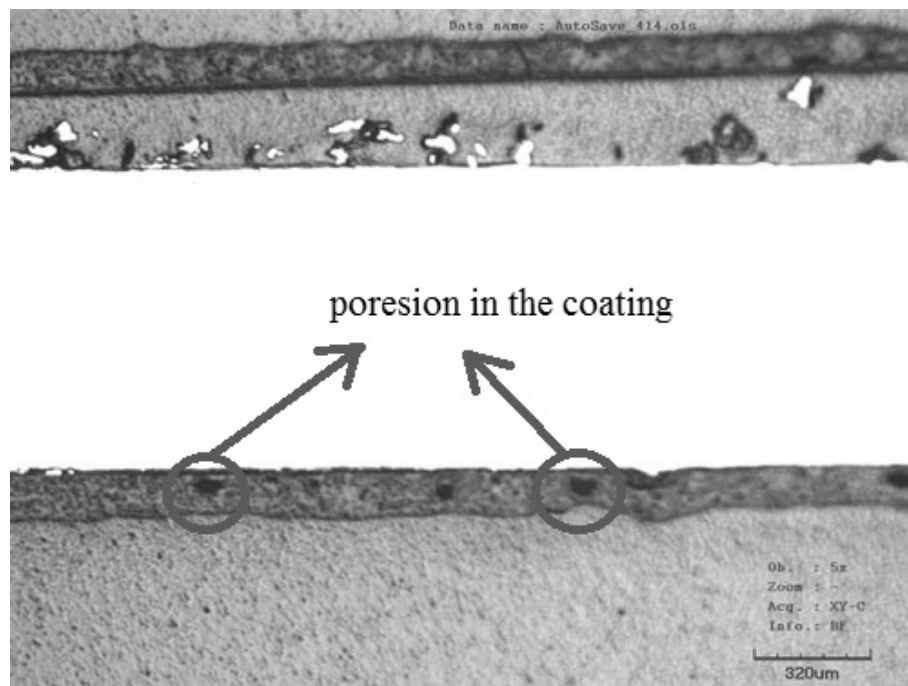
Fig. 5. V/4, defects in the surface coating
